Published in:
Proceedings of the International RILEM Conference

Citation (APA):
Nielsen, A. (2016). Durability of air lime mortar. In *Proceedings of the International RILEM Conference: Materials, Systems and Structures in Civil Engineering 2016 Segment on Historical Masonry* (pp. 109-115). Rilem publications.

DURABILITY OF AIR LIME MORTAR

Anders Nielsen

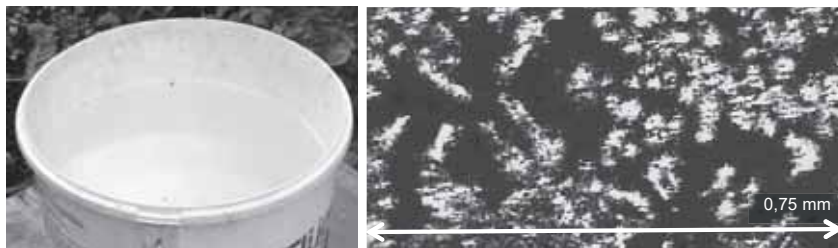
Figure 1. Carbonation on the surface of limewater. Crystals can be seen in the microscope.

When both calcium hydroxide and carbon dioxide are available, the carbonation process ($\text{Ca(OH)}_2 + \text{CO}_2 = \text{CaCO}_3 + \text{H}_2\text{O}$) is a relative fast process. This can be seen on the surface of freshly poured limewater in a bucket. In less than a quarter of an hour a grey layer has been created. It consists of very small crystals of calcium carbonate reflecting the light. The crystals can be seen in polarised light (Figure 1). During a week the crystal layer gets a thickness of 0.03 – 0.04 mm.

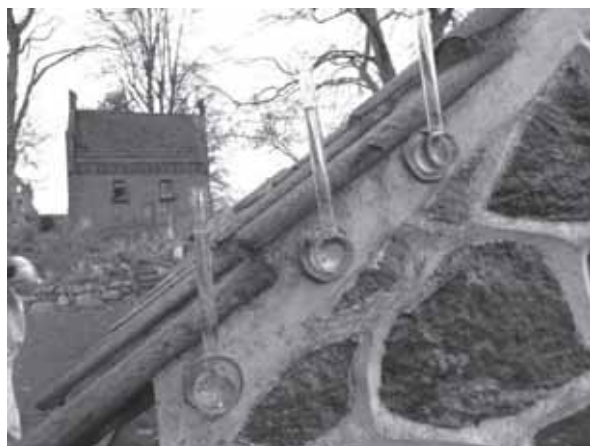
Figure 6. The 25% mortar developed by Ole Jensen was also used by the repair of a wall around the churchyard at Farum church. Picture is taken during measuring of capillarity with the Karsten tubes. (Photo: Martin Jensen)

The mortars from Kirke Værløse and Farum churches were included in a project, where the moisture properties of different air lime mortars were examined [3]. The capillary suction capacity was measured by means of the so-called Karsten tube.
